Debris/Ice/TPS Assessment and Integrated Photographic Analysis of Shuttle Mission STS-80

*Process Engineering/Mechanical System Division/ET-SRB Branch,
Kennedy Space Center, Florida*

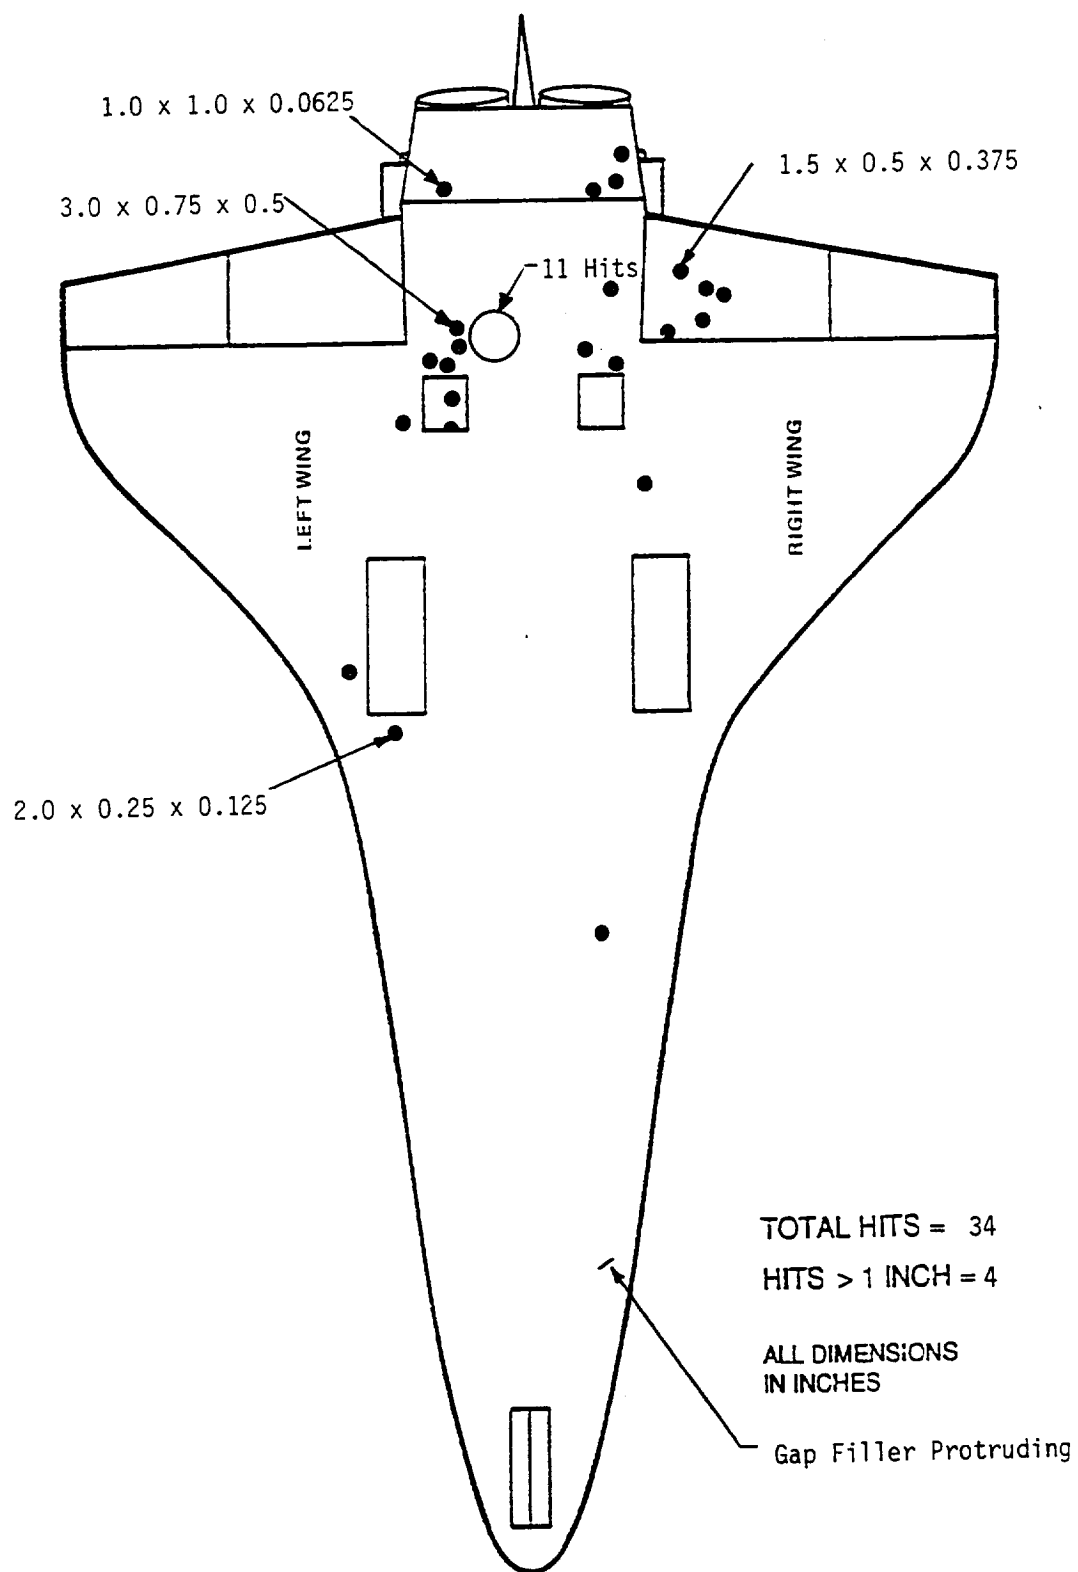
Figure 2: Orbiter Lower Surface Debris Map

The Orbiter lower surface sustained a total of 34 hits, of which 4 had a major dimension of 1-inch or larger. The largest lower surface tile damage site was located aft of the LH2 ET/ORB umbilical and measured 3-inches long by 3/4-inch wide by 1/2-inch maximum depth. The damage was most likely caused by an ice impact from the umbilical.

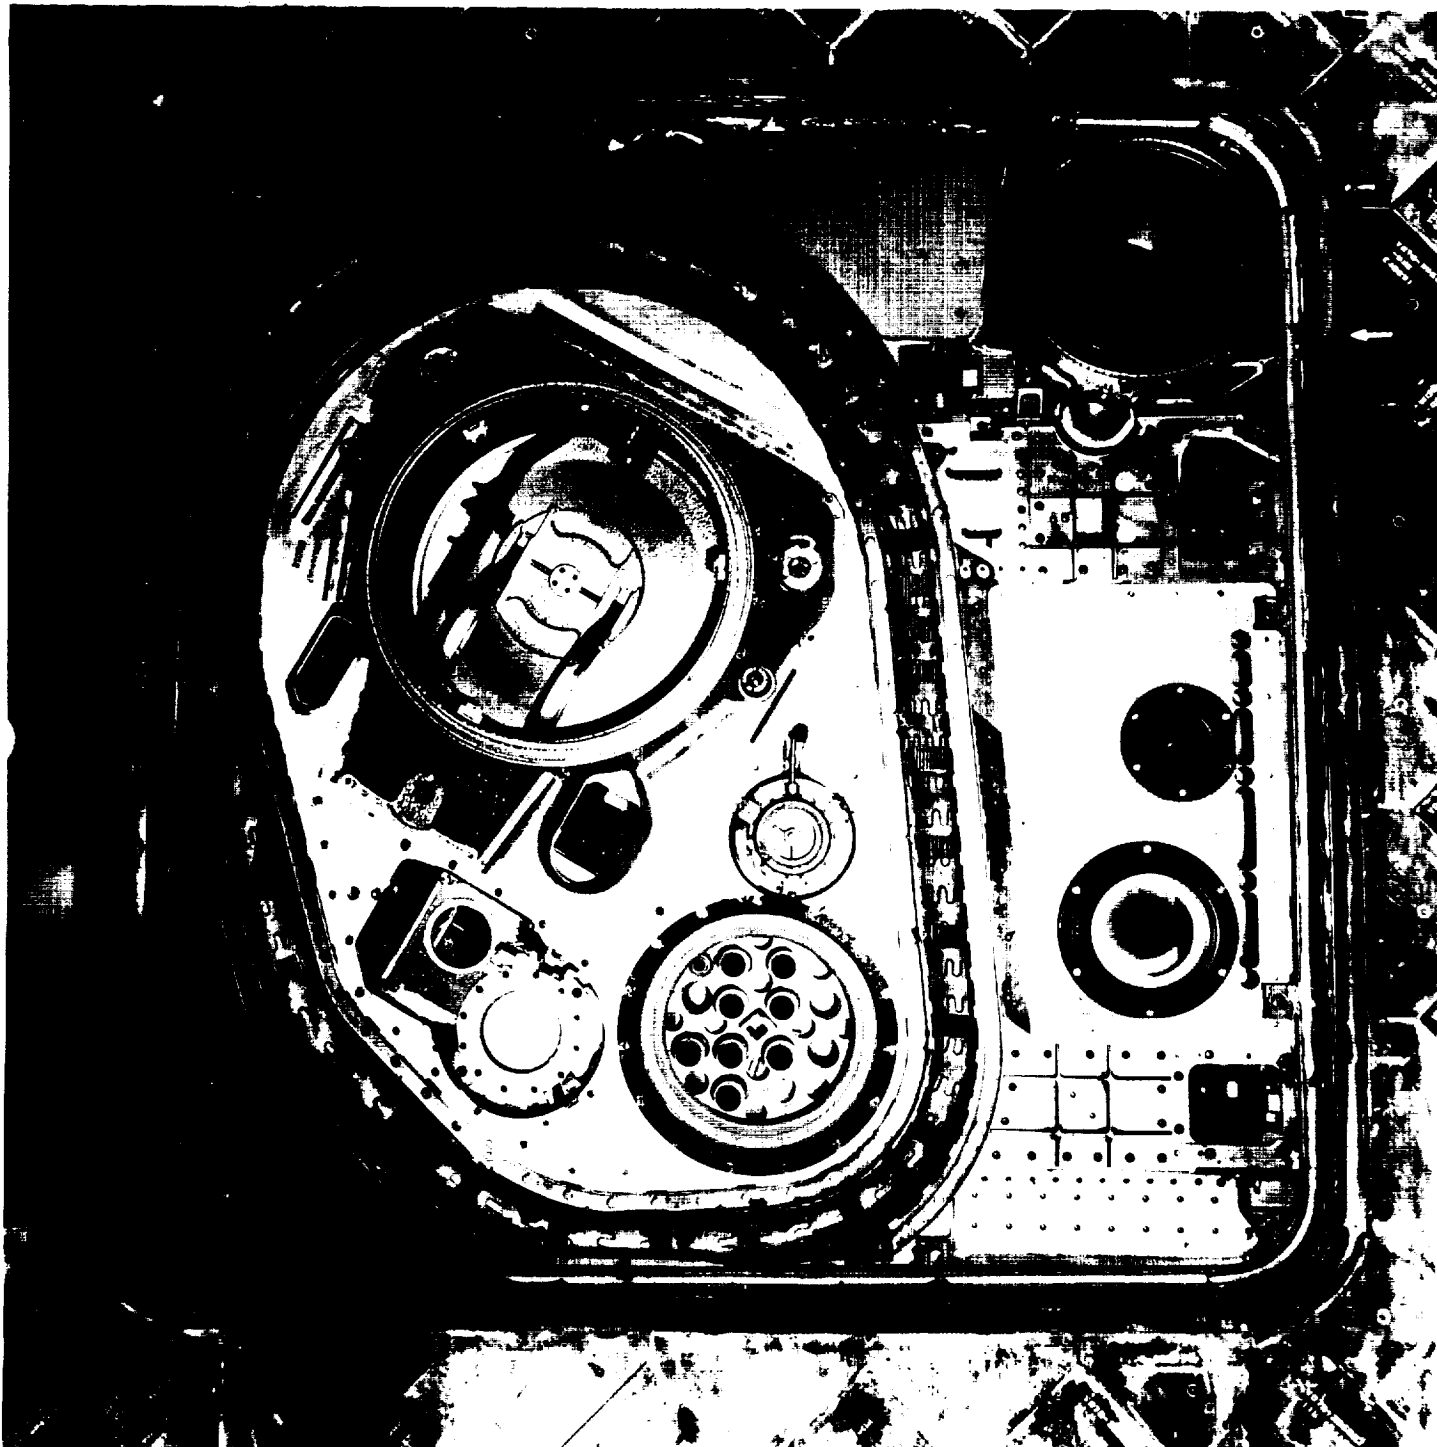
Photo 26: ET/ORB LH2 Umbilical

Less than usual amounts of ice/frost had accumulated on the LH2 ET/ORB umbilical purge barrier top and outboard sides. Typical ice/frost fingers were present on the pyro canister and plate gap purge vents. No unusual vapors or cryogenic drips had appeared during tanking, stable replenish, and launch.

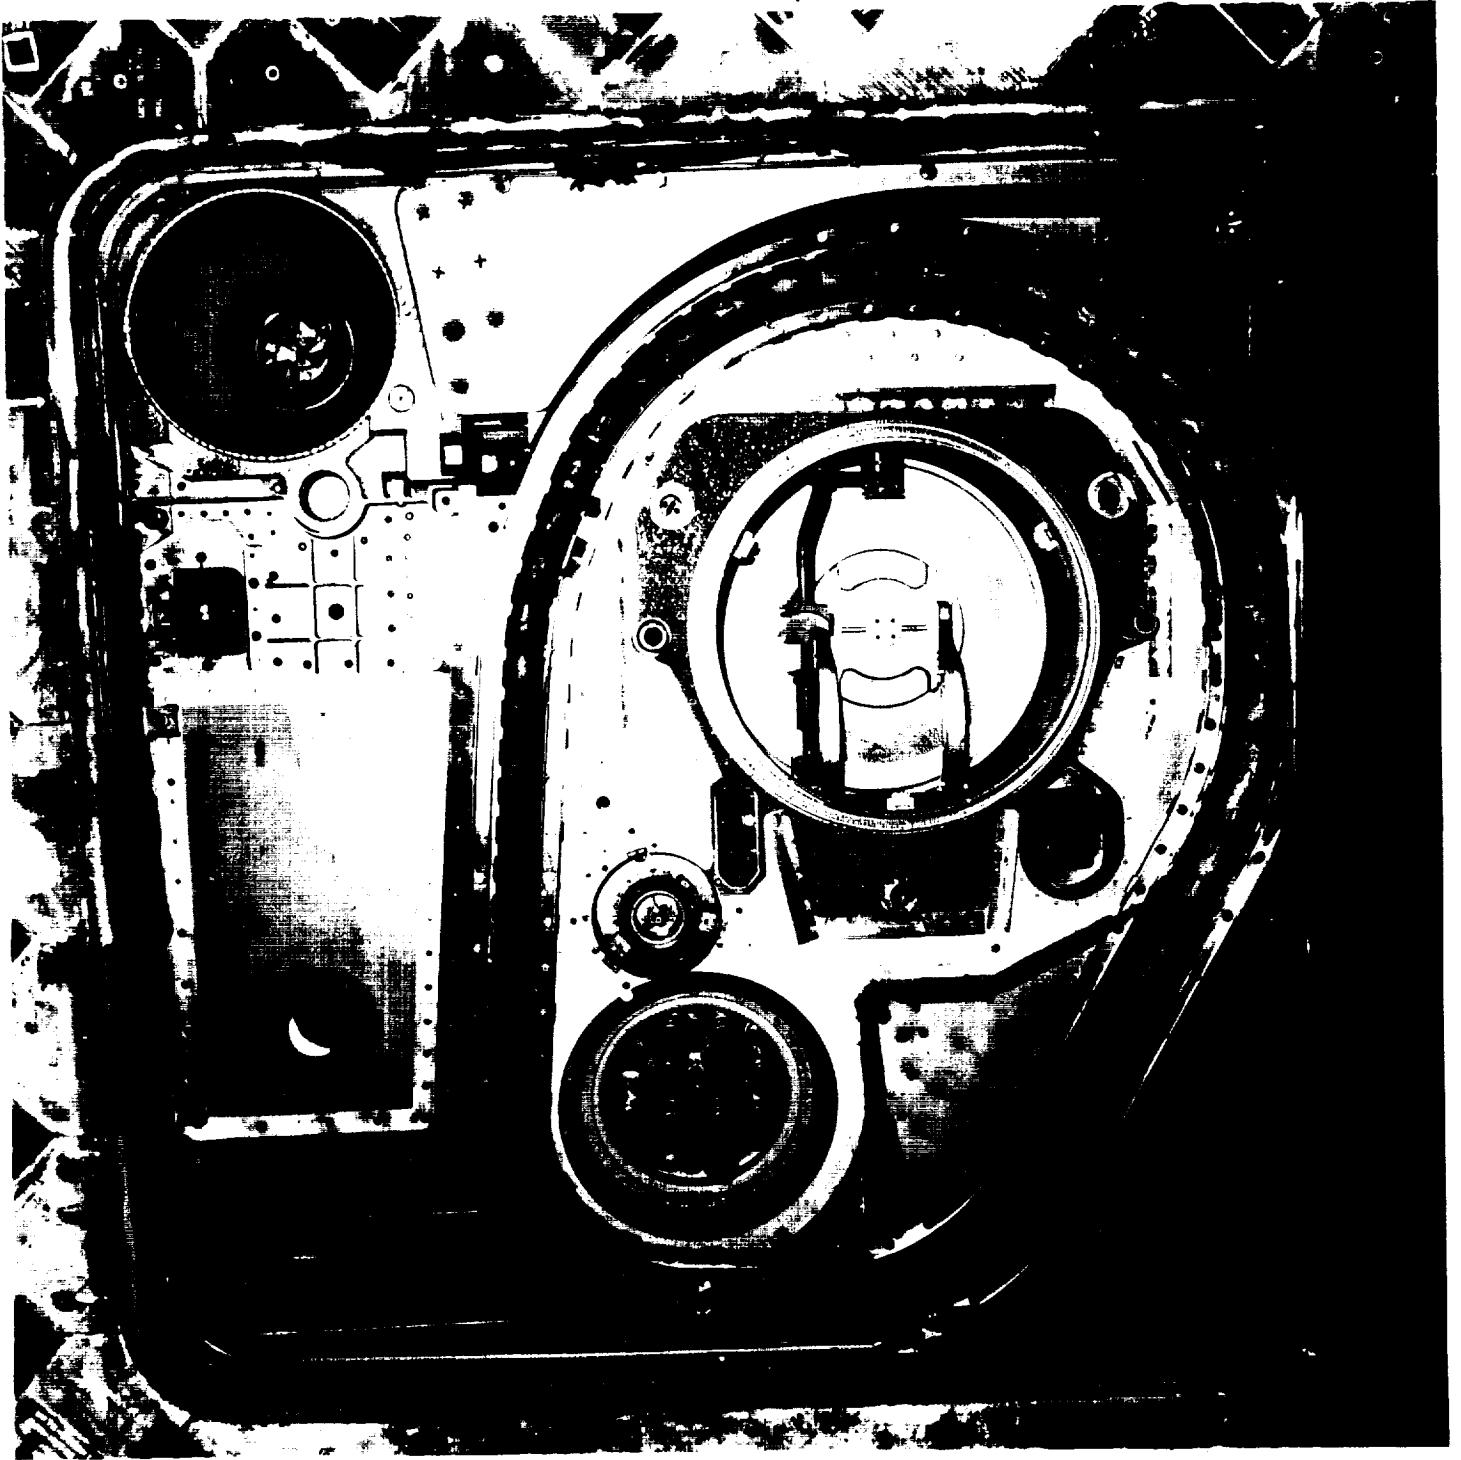
Photo 27: ET/ORB LO2 Umbilical

The LO2 ET/ORB umbilical sustained TPS damage during separation at the forward outboard corner. Two pieces of loose foam were visible in that area. Part of the RTV purge barrier was detached at the 2:00 o'clock position. Minor TPS damage also occurred on the umbilical aft surface near the electrical monoball. Numerous divots and eroded areas were visible on the horizontal and vertical sections of the cable tray. Lightning contact strips across the forward part of the umbilical and at the 8:00 o'clock position were missing. Loss of lightning contact strips has been the subject of previous IFA's.

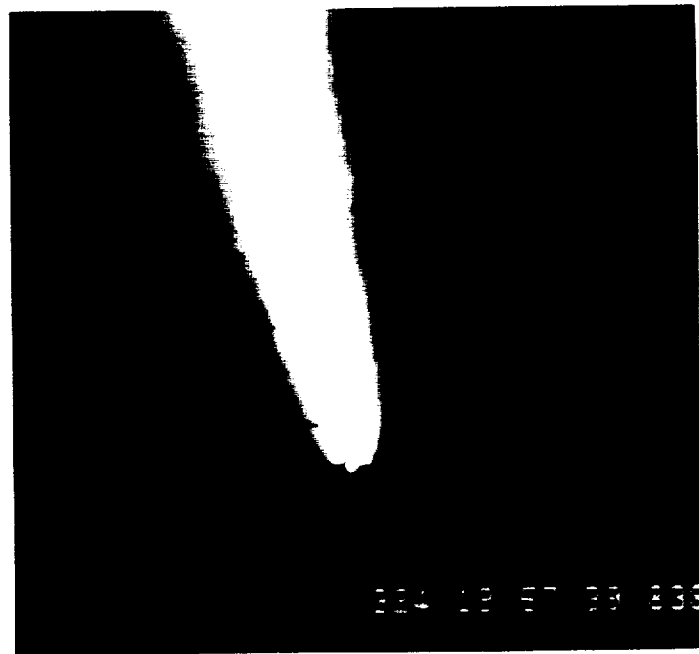
Figure 2.3 (B) Dark Puff In SRB Exhaust Plume

A dark puff was seen in the SRB exhaust plume at 11.1 seconds prior to SRB separation (19:57:39.8 UTC). (Cameras KTV4B, ET204)

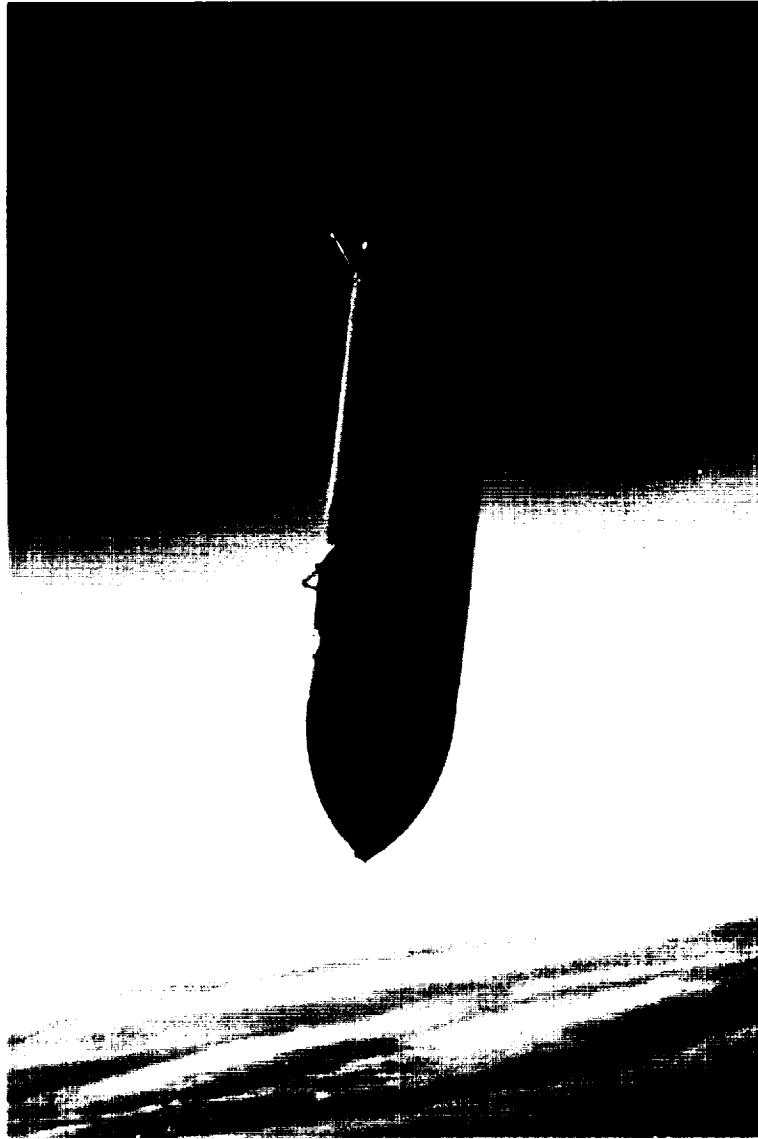
Figure 2.4.2 (A) Handheld View Of The External Tank

As can be seen above, back-lighting from the sun degraded the handheld views of the external tank. The previously used foam-covered intertank access door was flown on STS-80 (ET 80). The condition of the intertank access door could not be determined due to the poor lighting conditions.

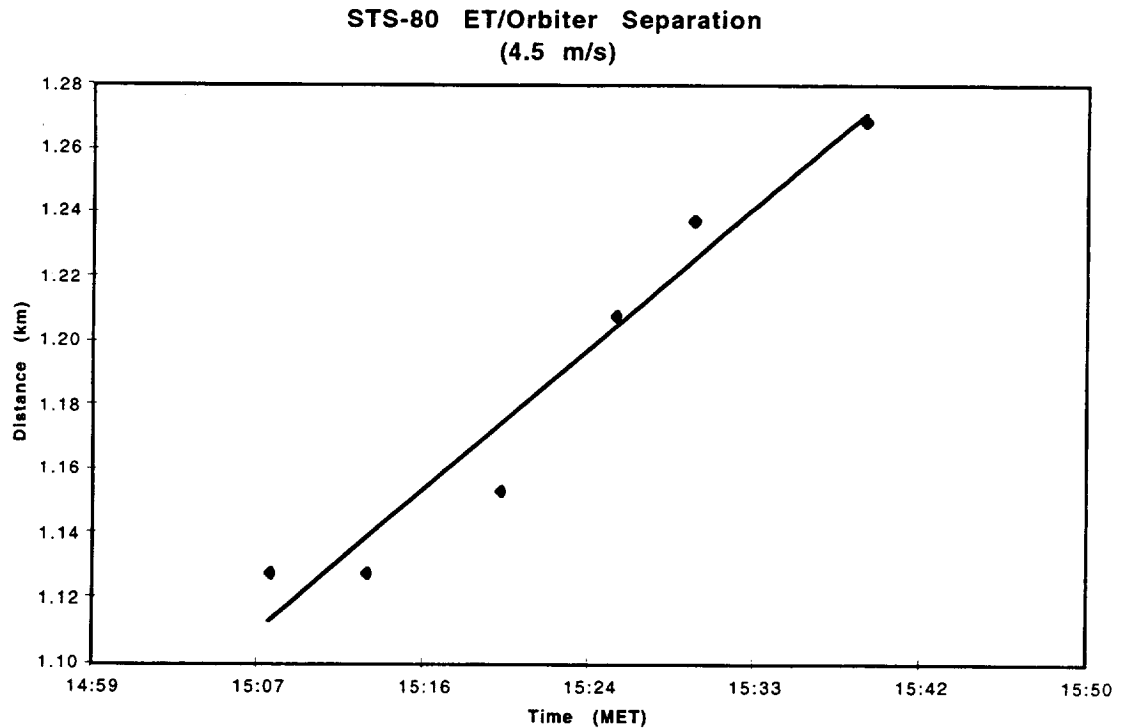
Figure 2.4.2 (B) ET Separation Velocity

The distance of the external tank was calculated over a six-frame sequence using the handheld photography. The external tank was calculated to be a distance of 1.1 km away from the Orbiter at 15:08 MET. The tank was calculated 31 seconds later (15:39 MET) to be at a distance of 1.3 km. The tank separation velocity was determined to be 4.6 m/s. The separation velocity was similar to previous mission measurements. The tank tumble and roll rates could not be determined due to the poor lighting conditions.

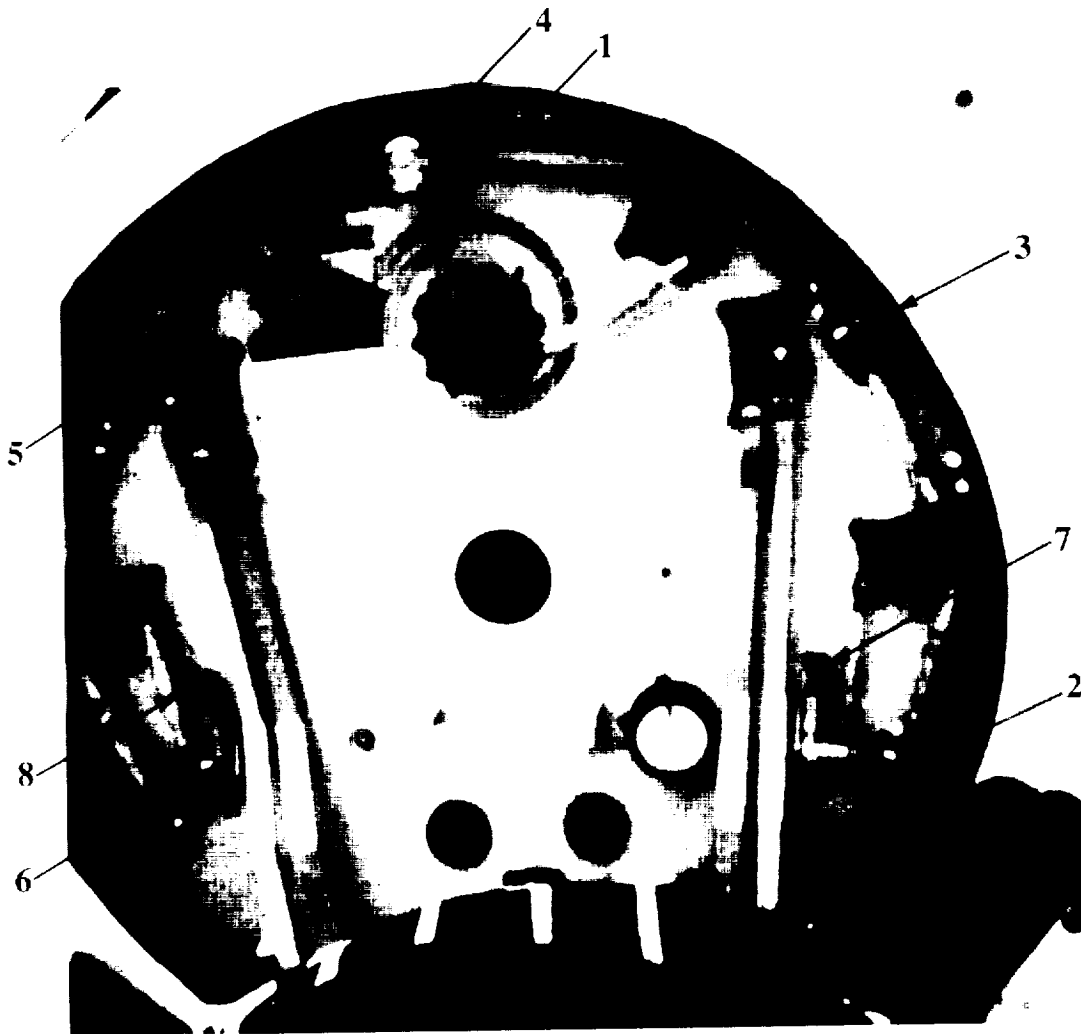
Figure 2.5.1 Airlock Hatch (Exterior)

The orientation of each latch link was measured relative to the deflection angle of each latch link using close-up views from video acquired with the end-effector camera positioned approximately face-on to each latch link (Figure 2.5.1, annotations 2-6). The total rotation of a latch link from fully latched to its dead-on-center (DOC) perpendicular orientation was approximately 2.15 degrees. At the maximum jammed position, latches 1, 2, 3, and 4 were definitively observed to rotate beyond DOC in the unlatched direction (total rotations from fully latched of 5.5, 4.9, 5.8 and 7.5 degrees respectively). Latches 5 and 6 were observed to probably rotate beyond DOC in the unlatched direction, but the observations were not definitive due to uncertainty in the measurements.

Video of the simultaneous motion of both deployable legs was analyzed (Figure 2.5.1, annotations 7 and 8). Both legs reached their jammed position within one video frame of each other, corresponding to a time difference of less than approximately 0.03 seconds. The starboard leg reached its jammed position first.

During the post-flight inspection conducted by engineers at KSC, a loose screw was found lodged in the actuator gearbox (Figure 2.5.1, annotation #1). This loose screw jammed the handle preventing the crew from opening the hatch on orbit.

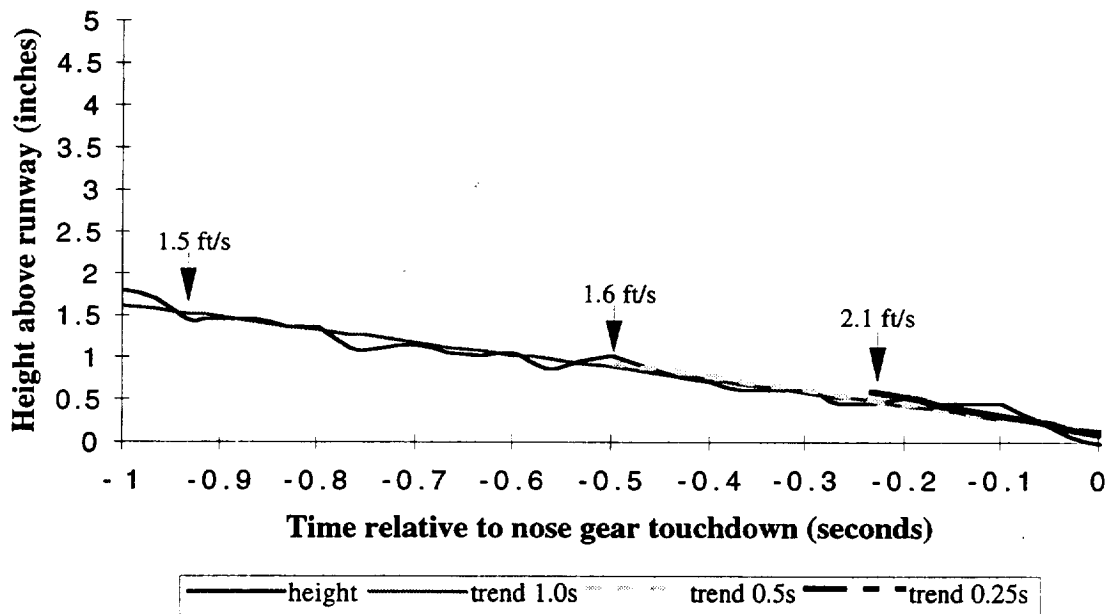
Figure 2.6.1 (A) Main Gear Height Versus Time Prior To Touchdown (Video)

The measured main gear sink rate values were found to be below the maximum allowable values of 9.6 ft/sec for a 211,000 lb. vehicle and 6.0 ft/sec for a 240,000 lb. vehicle (the landing weight of the STS-80 Orbiter was reported to be 227,523 lb.). The sink rate measurements for STS-80 are given in Table 2.6.1. In Figure 2.6.1(A), and 2.6.1(B), the trend of the measured data points for the image data is illustrated.
